Att.: Participants of the TKI 'Warmteoverdracht
drinkwaterleidingen'
Subject: Results temperature measurements in Krimpen aan den
IJssel 2018 and validation 2D-Soil temperature model
From: Claudia Agudelo-Vera, Mario Castro Gama and Mirjam
Blokker (KWR) and Sam van der Zwan and David
Nugroho (Deltares)

1 Introduction

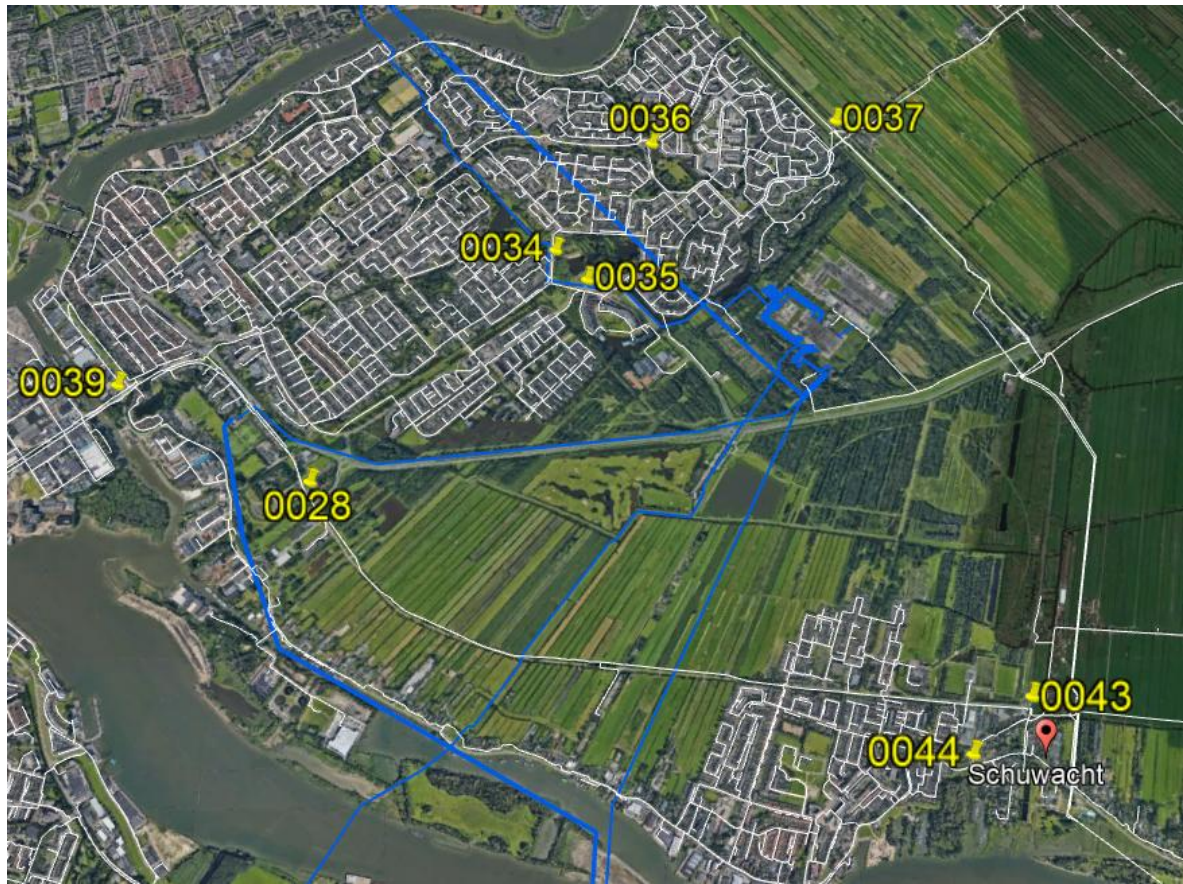
Figure 2 Overview of the eight measurement locations in Krimpen aan den IJssel and Krimpen aan de Lek. In white the drinking water pipes, in yellow the ID's of the corresponding DMAs: 0028, 0034 - 0037, 0039, 0043 and 0044), in blue the high voltage cables, the red pointer is the treatment plant Schuwacht.

Soil temperature measurements were conducted in the city of Krimpen aan den IJssel (The Netherlands) for the validation of the 2D-STM. The measurement period was July until October 2018. Soil temperatures were measured and registered every hour. The eight measured locations are close to flow meters of Oasen, see number of the respectively DMA in Figure 2. At these same locations there were supposed to be temperature measurements of the drinking water, but in the end this turned out to not be the case. The results of the measurement at eight locations are summarized in Chapter 2. 1D soil temperature simulations are shown in Chapter 3, validation of the 2D-STM is shown in Chapters 4 and Chapter 5 contains a final discussion and concluding remarks.

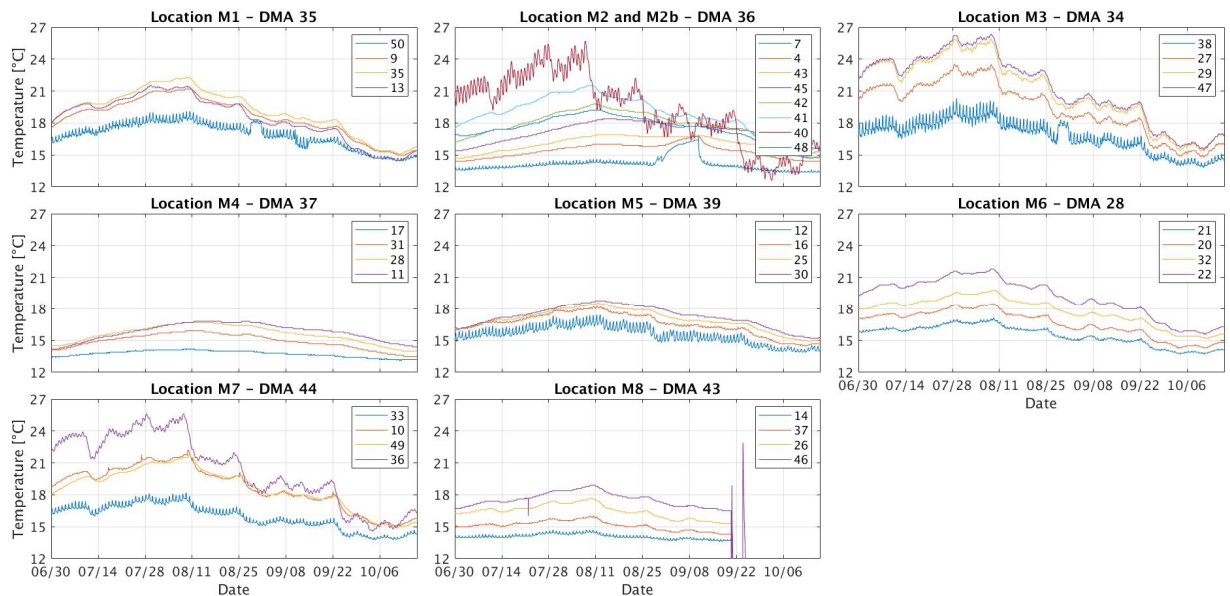
Figure 4 Temperature measurements at eight locations at the depth of the drinking water pipe. At location M2, there were horizontal and vertical measurements. The colours represent the thermometer ID.

The measurements were conducted at different depths, ground water levels, soil type and cover conditions. Therefore direct comparison of the measurements is not possible. The KNMI reported that the summer of 2018 was the hottest summer in at least 3 centuries and that the autumn of 2018 was the sunniest autumn in more than a century.

The measurements corroborate that soil temperature varies locally depending on several variables and that in an urban setting the local differences are significant. In all the locations, the thermometers close to the drinking water pipes registered the lowest temperatures and with a diurnal pattern, with a daily variation of approx. 1.5 °C for pipes above 90 cm and a small variation of 0.1°C (which is the precision of the sensors) for pipes below 90 cm, Figure 5. Temperature profiles change according to the locations and the local characteristics. There is a difference between the locations of 6 degrees in the measurements close to the drinking water pipe. Locations M2 (-1.40m), M4 (-0.9m) and M8 (-1.20m) showed a lower temperature that the rest around 14°C.

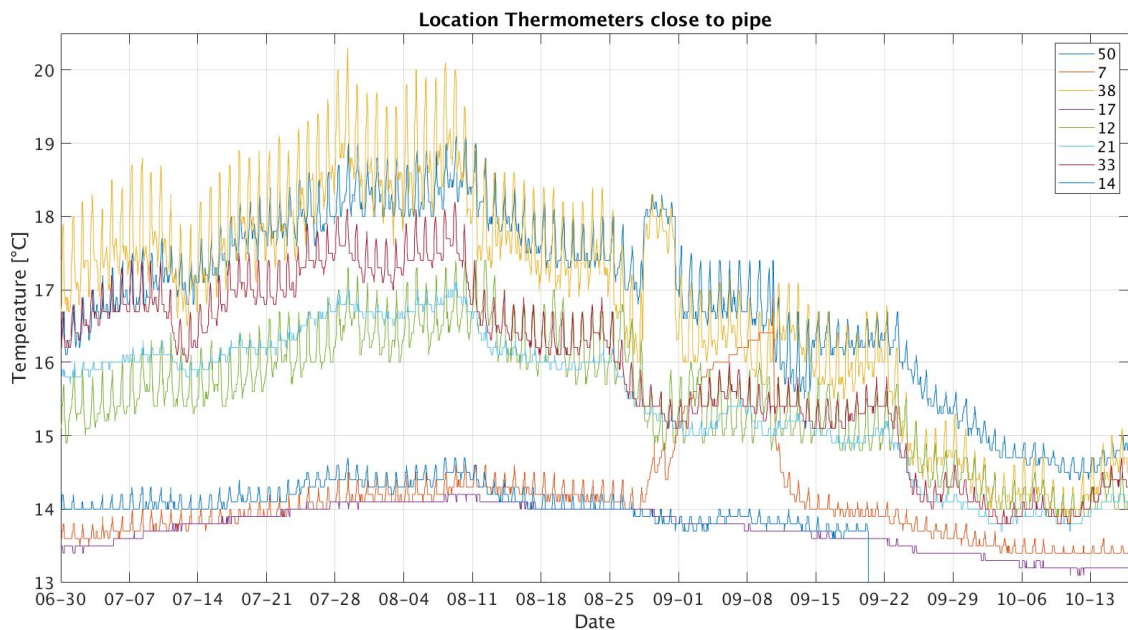
Figure 5 Temperature measurements at the pipe wall in the eight locations from M1 to M8. In the legend the number of the thermometer: 50=M1, 7=M2, 38=M3, 17=M4, 12 = M5, 21 = M6, 33 = M7 and 14=M8.

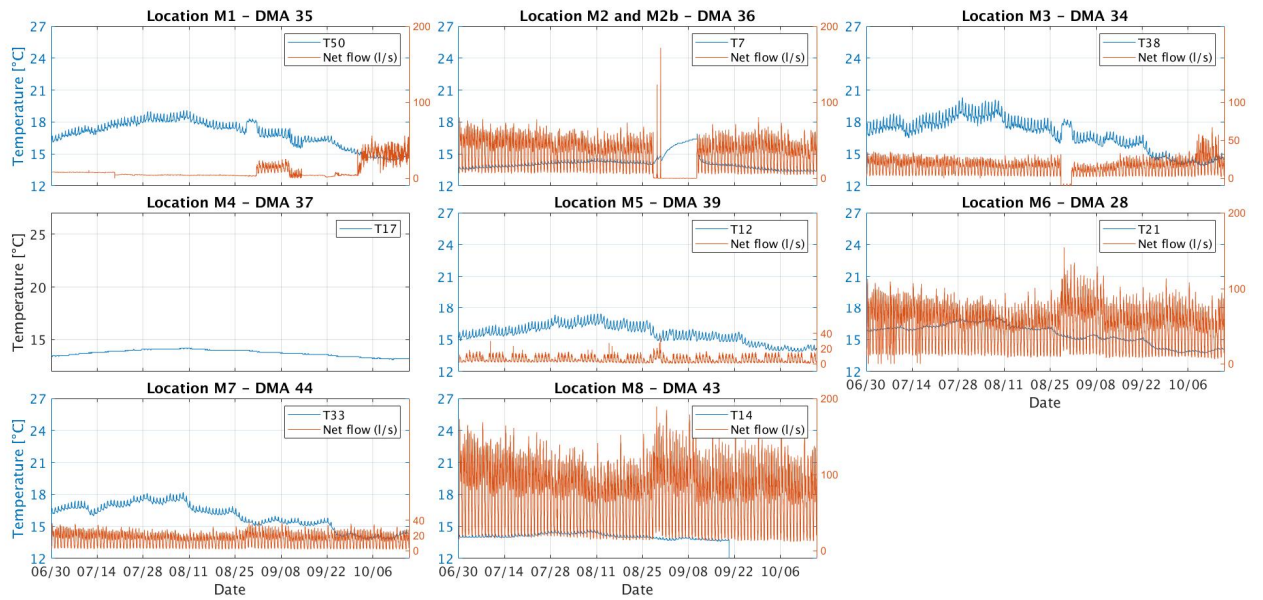
Figure 7 Temperature measurements close to the drinking water pipe (in blue) and flow measurements per location (in red), there was no data available for location M4.

Location M2 has an abrupt change starting on 28 August and finishing on 13 September, which shows an increase of almost 3 degrees on 10 September. Analysis of the flow measurements in the DMA, shows that in this period a valve was closed, which led to stagnant water (flow=0), see Figure 7 (location 2). Changes in the flow in the network actually influences the temperature of the drinking water pipe, as show in Locations M1 and M3 which also have a flow anomaly starting in the same period but of a shorter duration, and that variations cause an anomaly in the temperature series.

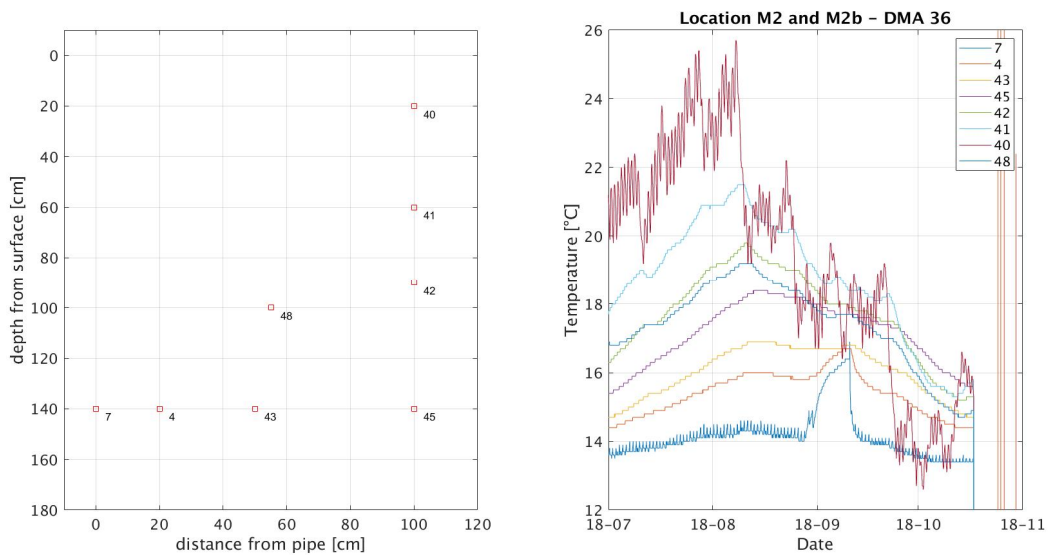
Figure 10. Measured temperature on each thermometer on location M2 between 29 June and 18 October 2018

The measurement layout on location M2 is presented in Figure 9. The underground was clay with grass as top layer. Both drinking water pipe and a low voltage electricity cable were present. The drinking water pipe is made of PVC material and has an outside diameter of 400 mm. The diameter of the electricity cable was not measured and will be assumed in the validation calculation. The center of the drinking water pipe and the electricity cable is located at 1.4 m and 1 m from the surface respectively. 8 sensors (thermometers) were placed in the underground (T7, T4, T43, T48, T40, T41, T42 and T45). T7 is located near to the drinking water pipe. T48 is located near to the electricity cable. Ground water table was found at depth of 0.8 m. Figure 10 shows the results of the measurements.

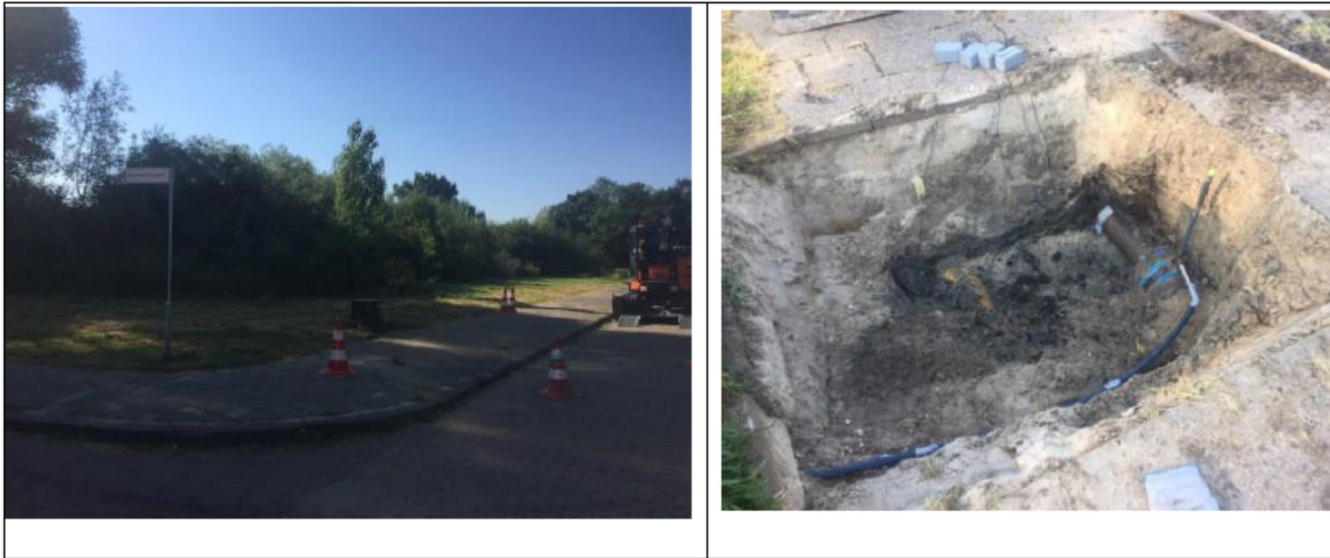
Figure 13 Measurement layout on location M3

The measurement layout on location M3 is presented in Figure 13. The underground was mixed of clay and sand with tile as top layer. Only drinking water pipe was present. The drinking water pipe is made of PVC material and has an outside diameter of 160 mm. The center of the drinking water pipe is located at 0.7 m from the surface. Four sensors (thermometers) were placed in the underground (T38, T27, T29 and T47). T38 is located near to the drinking water pipe. Ground water table was found at depth of 1 m. The measurement results are shown in Figure 14.

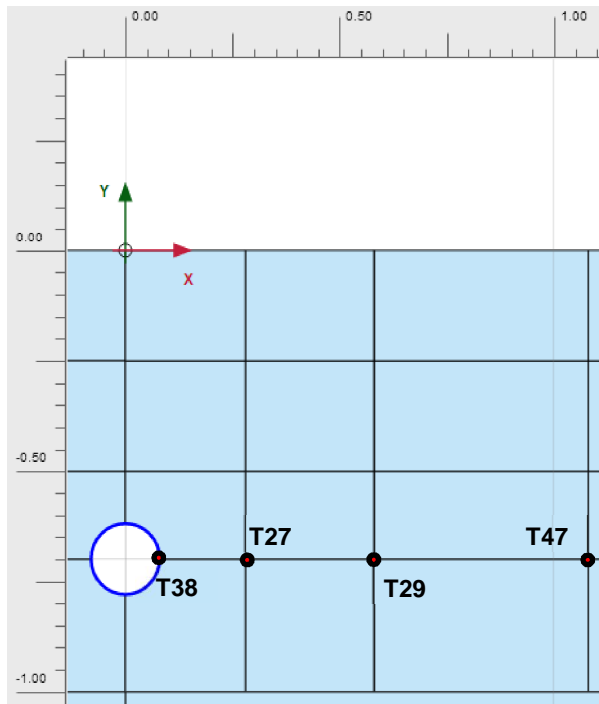
Figure 15 Part of the model used for the validation of measurement on location M3

- Surface temperature of TMZK scenario for a situation of Rotterdam in 2018 and sand-clay underground (WP2).
- PVC pipe with an outside diameter of 160 mm.
- Initial temperature uses the temperature profile (with depth) on 29 June.
- The measured temperature of T38 was applied at the drinking water pipe.
- Temperature boundaries follow WP2.

Figure 15 shows part of the model used for the validation.

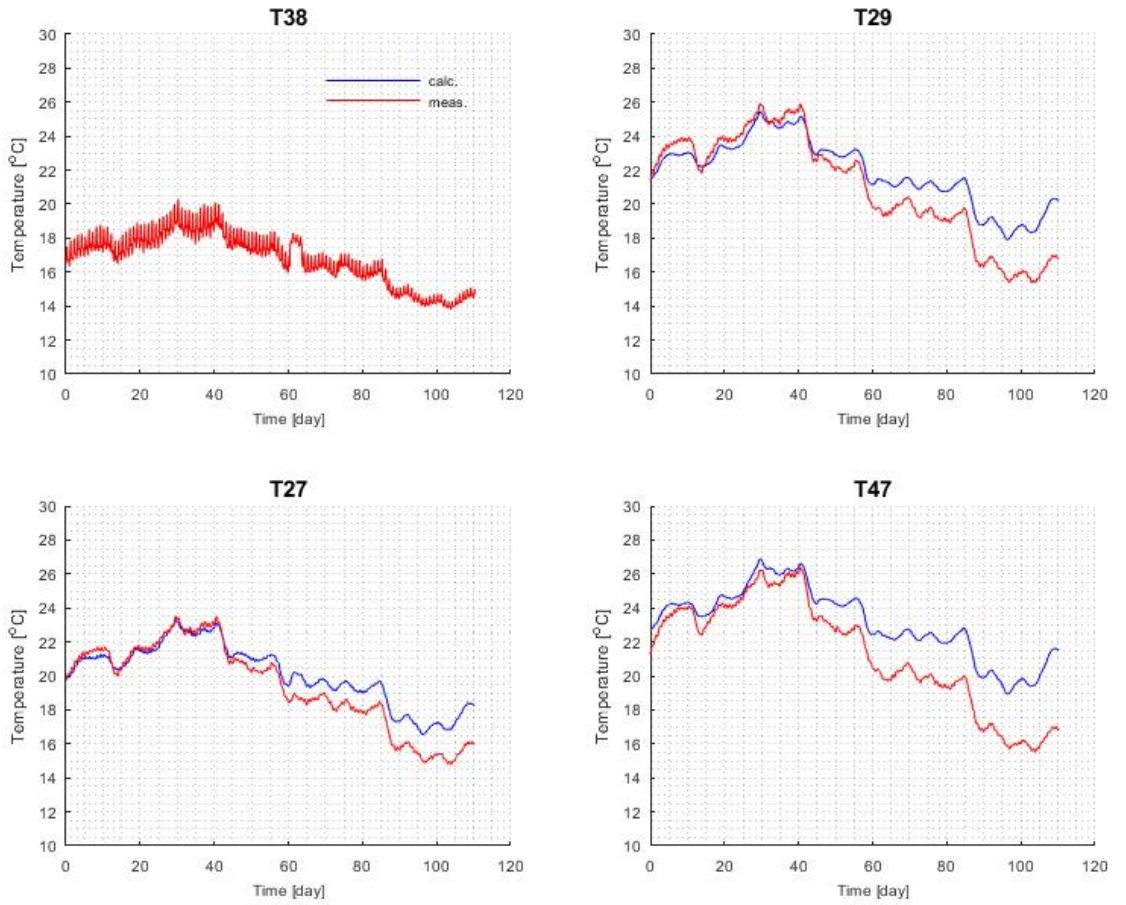
Figure 16 Measured and calculated temperatures at the different measurement locations (bottom temperature boundary at 10 m depth)

Figure 16 show a comparison between measured and calculated temperatures (day 0 is 29 June 2018). T38 is used a boundary condition. It can be observed that the calculated temperatures from day 0 to 40 are reasonably in agreement with the measured one. On day 60 the calculated temperatures start to deviate and are larger than the measured ones. This has to do with the top boundary condition which also shows a deviation from the measurements from day 40, see Figure 8. Concluding the 2D soil temperature model captures the physics correctly, however the results are much influenced by the boundary condition.

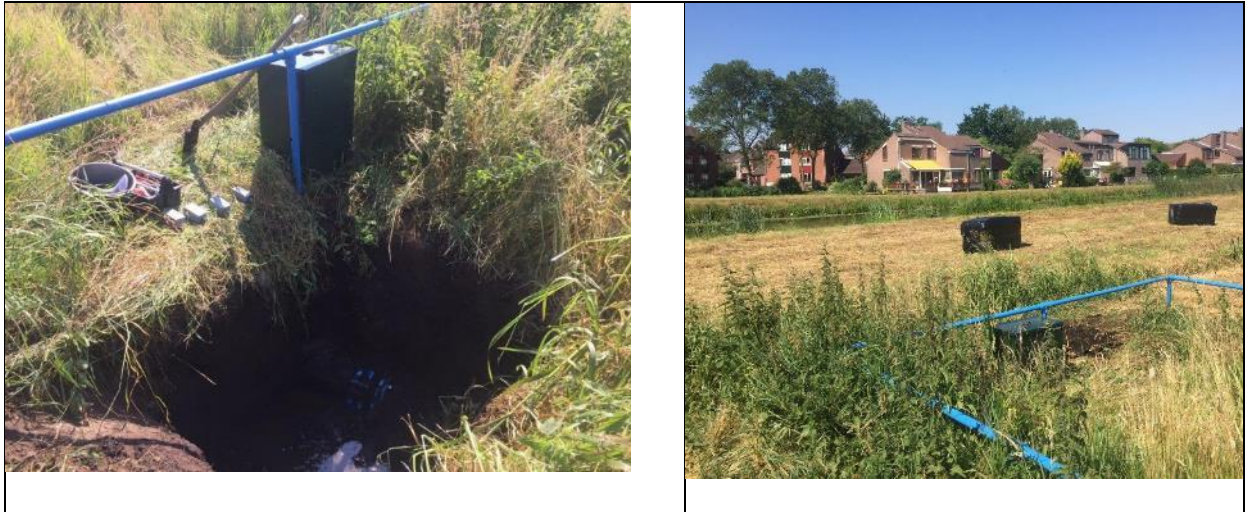
Figure 19 Surroundings and detail of the measurement set-up in location M4

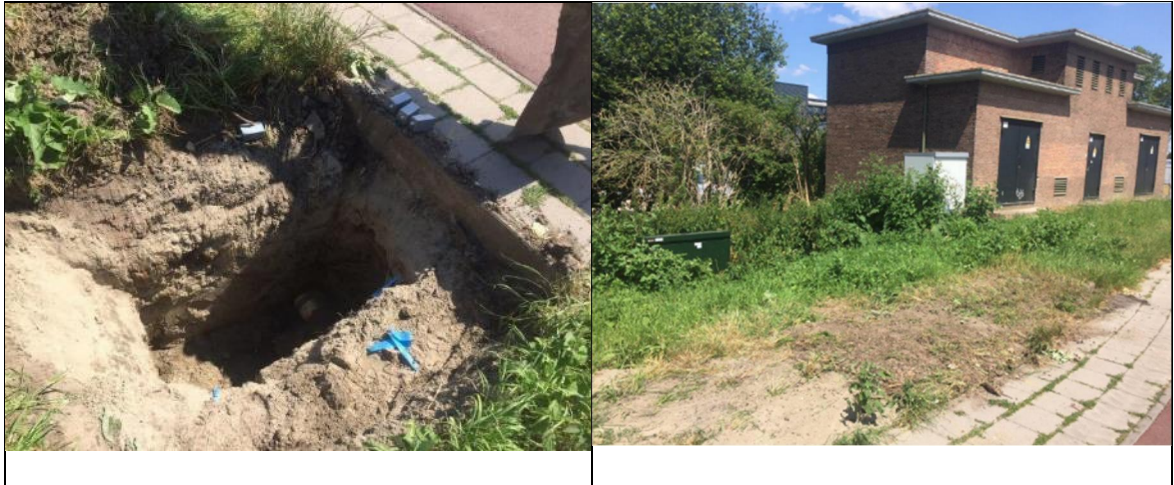
Figure 21 Surroundings of the measurement set-up in location M5

Table 1 summarises the characteristics of the locations and results of the measurements. The maximum measured temperature was 26.4°C in location M3 at a depth of 0.7 m. This temperature was registered in a location close to an electricity cable with clay soil and under grass. There were two other locations with temperatures above 25 °C: location 2 & 7 at a depth 0.20 m and 0.90 m, respectively. Residence times were calculated using the hydraulic model of the area. Underground heat sources found in the locations are low voltage electric cables. At locations M3 and M4 there are high voltage electric cables at a horizontal distance of 20 and 24 meters respectively. In location M5 there is an Electrical distribution sub station

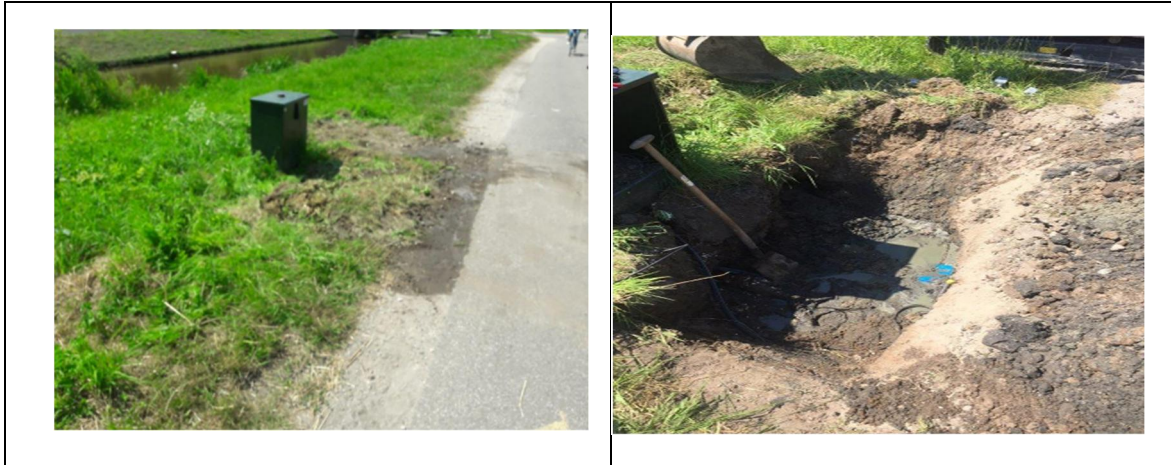
Figure 23 Surroundings of the temperature measurements in location M6

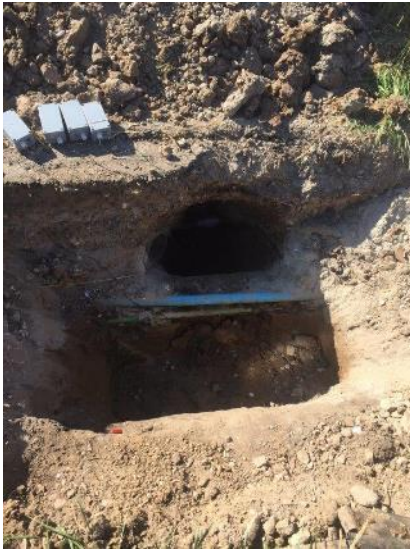
Figure 27 Detail of the temperature measurements in location M7

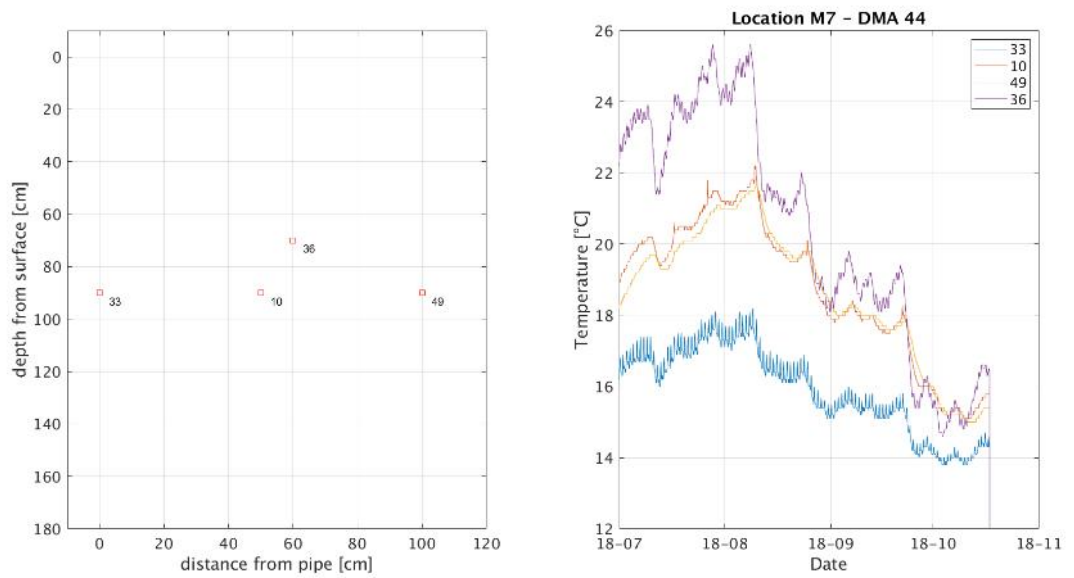
Figure 28 Temperature measurements in location M7

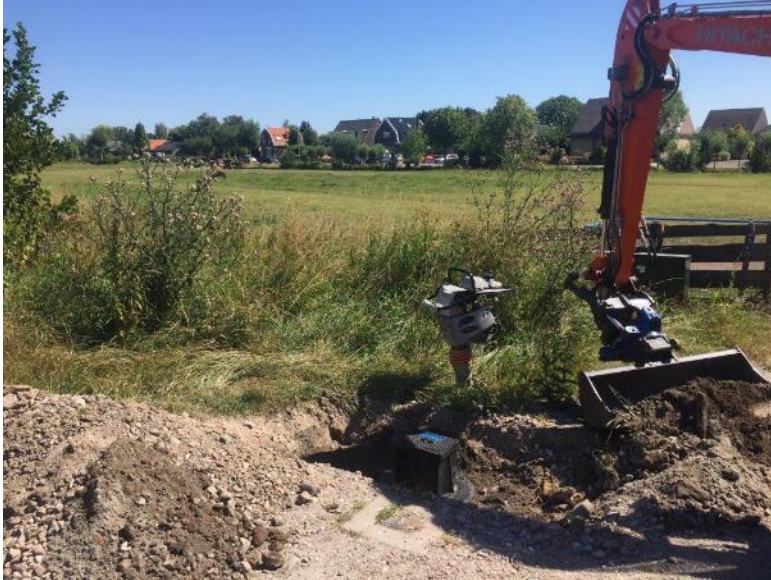
Figure 29 Detail of the temperature measurements in location M8
